UNITED STATES ENVIRONMENTAL PROTECTION AGENCY  
REGION 5  
77 WEST JACKSON BOULEVARD  
CHICAGO, IL 60604-3590

Re: Notice of Violation  
RCRA Compliance Evaluation Inspection – Print Craft, Inc.  
EPA ID No.: MND 982 623 357

INSTALLATION NAME: Print Craft, Inc.  
U.S. EPA ID. No.: MND 982 623 357  
LOCATION ADDRESS: 315 5<sup>th</sup> Avenue NW  
New Brighton, MN 55112  
DATE OF INSPECTION: November 12, 2014  
U.S. EPA INSPECTOR: Sheila Burrus

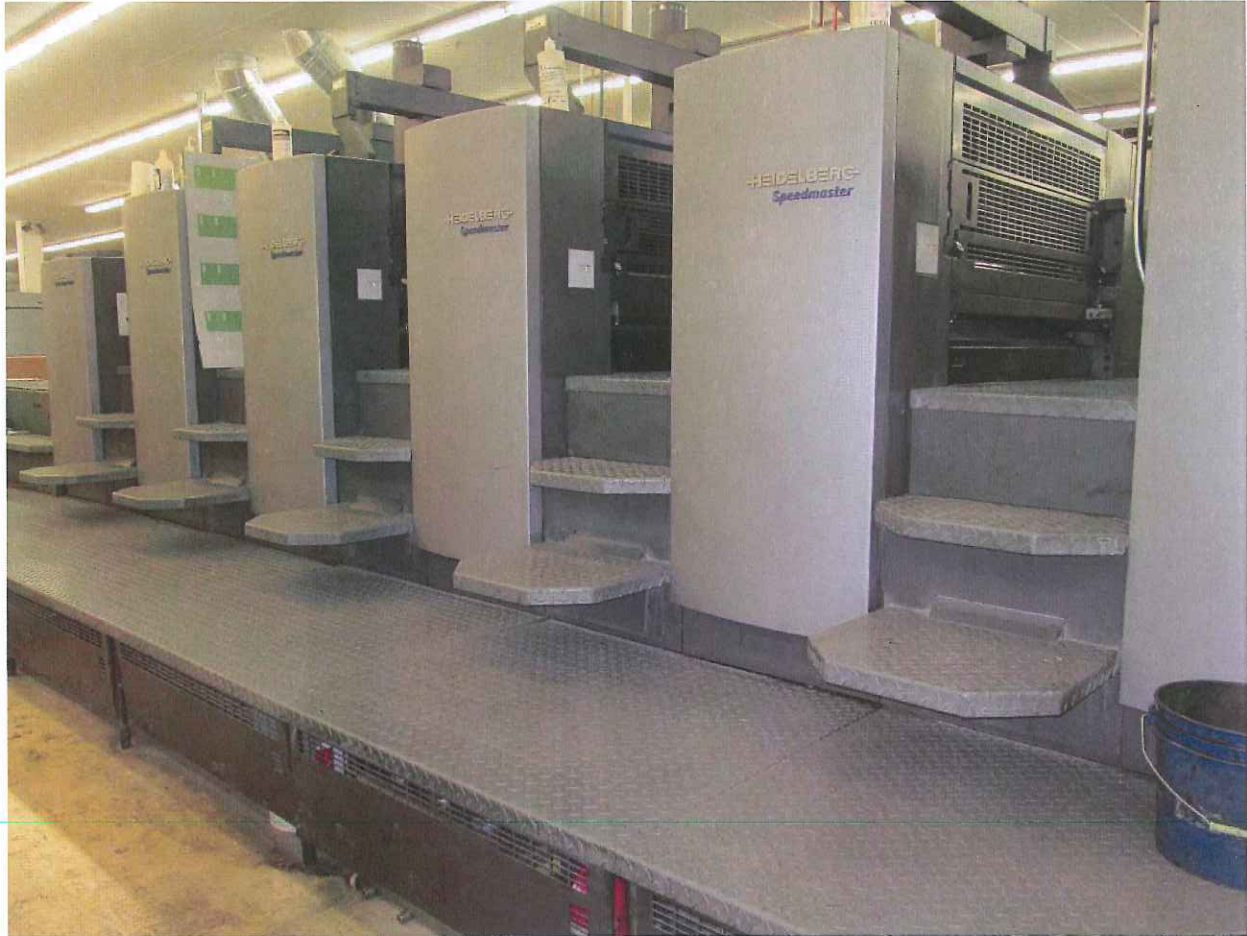
PHOTOGRAPH: 1

- There were five, 3-gallon labeled/closed satellite accumulation containers of waste petroleum distillates (waste solvent) next to the 5-color printing press (Photographs 1 and 2).

5-Color Printing Press

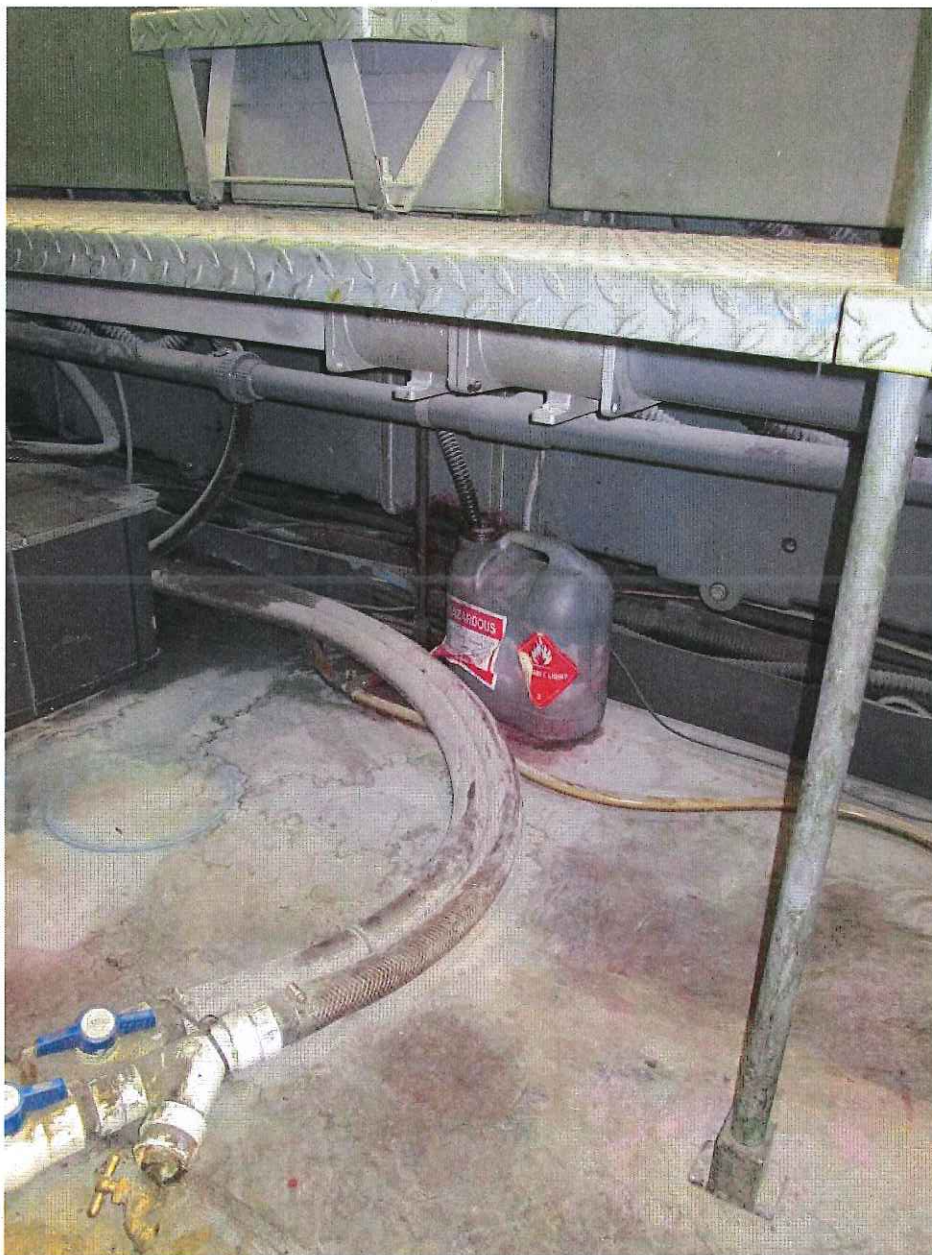
PHOTOGRAPH: 2

3-gallon satellite accumulation container of waste petroleum distillates (waste solvent)

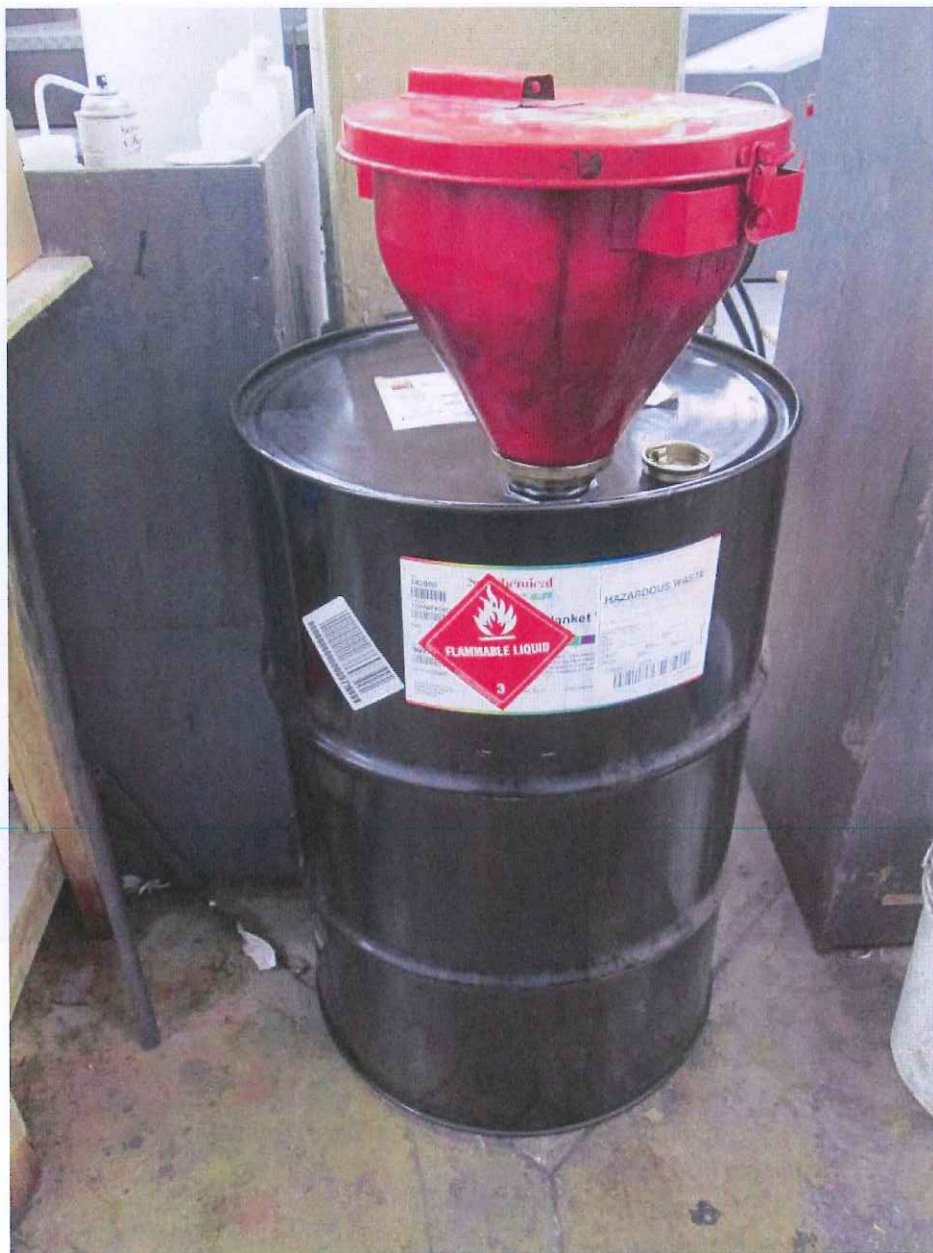
PHOTOGRAPH: 3

At the time of the inspection, Print Craft's labeled a 55-gallon satellite accumulation container of waste petroleum distillates (waste solvent) as "combustible liquid."

- There was a 55-gallon satellite accumulation container of waste solvent located near the 5-color printing press. The hazardous waste label on the container described the waste as combustible liquid instead of waste petroleum distillates (waste solvent). The label was immediately removed and replaced with a hazardous waste label with the description of waste petroleum distillates (Photographs 3 and 4).

mislabeled 55-gallon satellite accumulation container of  
waste petroleum distillates (waste solvent)

During the inspection, as observed by EPA, you took action to establish compliance with the above marking/identification requirements in paragraphs 4 and 5. According to Section 3008(a) of the RCRA, EPA may issue an order assessing a civil penalty for any past or current violation, requiring compliance immediately or within a specified time period, or both. Although this letter is not such an order, or a request for information under Section 3007 of RCRA, 42 U.S.C. CFR § 6927, we request that you submit a response in writing to us no later than thirty (30) days after receipt of this letter documenting the actions, if any, you have taken related to paragraphs 1-3.

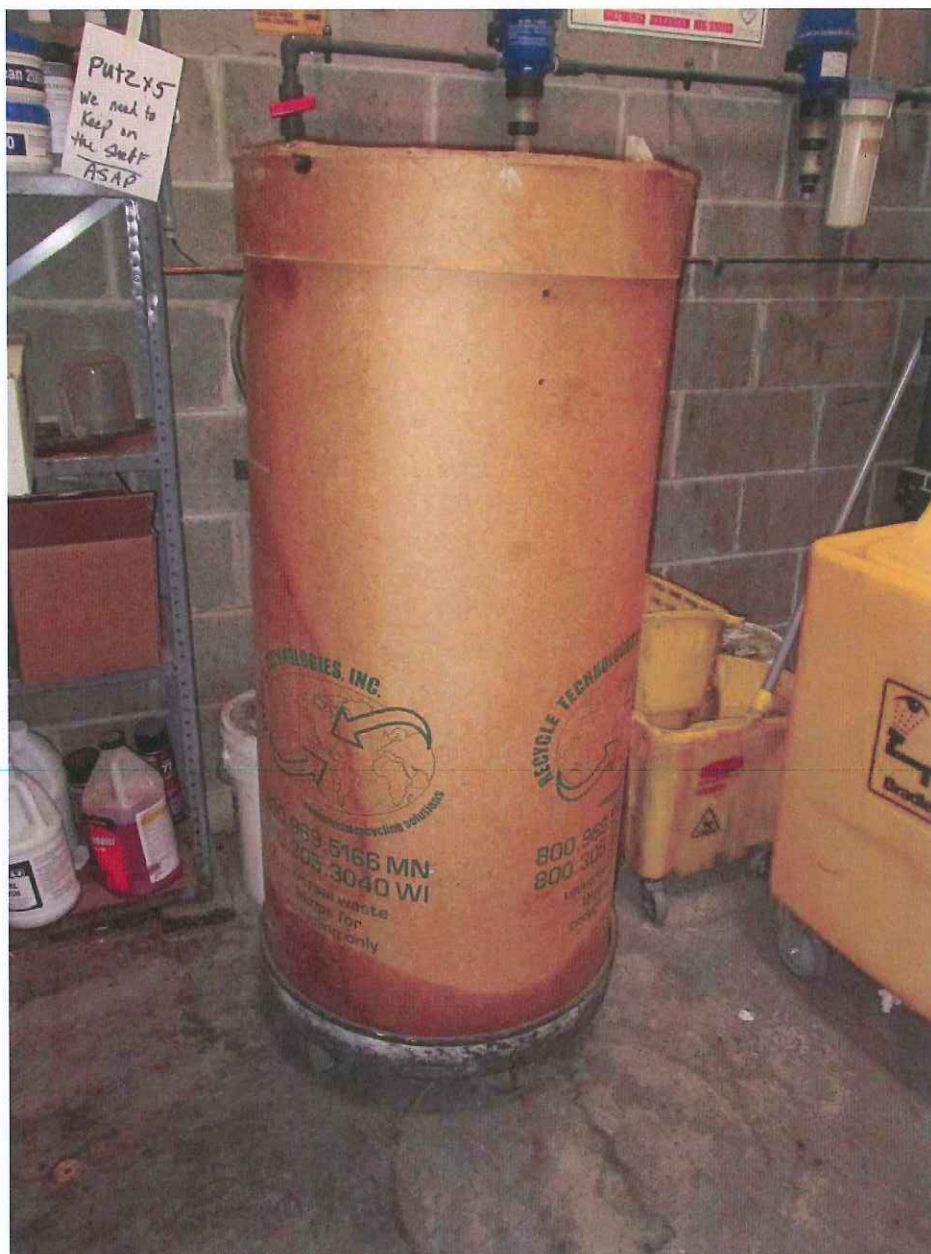
PHOTOGRAPH: 5

- There was one closed/labeled container of waste lamps in the chemical storage room (Photograph 5).
- There was one closed/labeled full and one partially filled 55-gallon containers of used oil in the chemical storage area (Photograph 6 and 7).

closed/labeled waste lamps
